### HYDROGEN-OXYGEN ELECTROLYTIC REGENERATIVE FUEL CELLS

Contract NAS 3-2781

EOS Report 4110-2Q-1

26 July, 1964

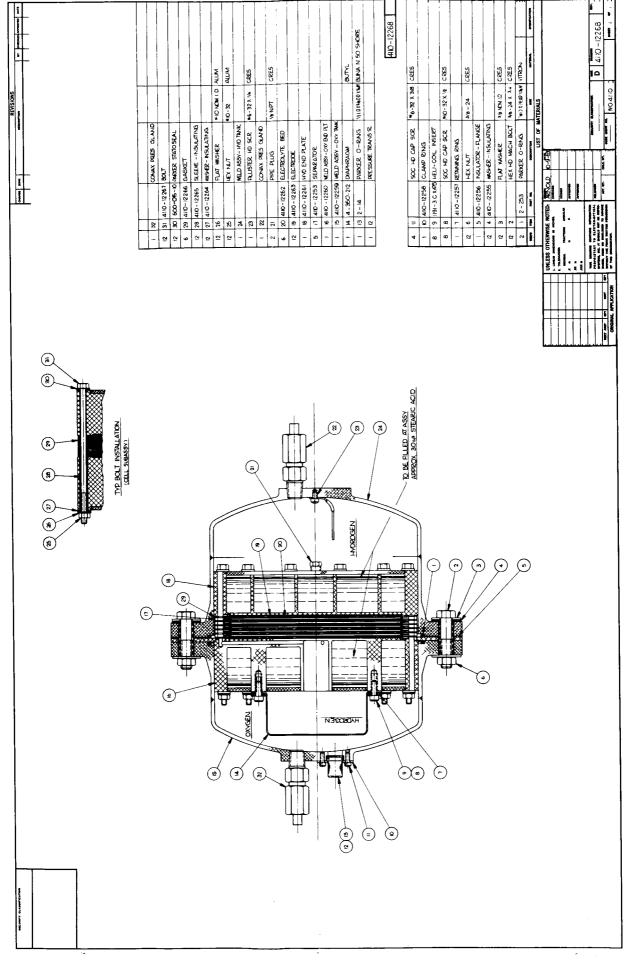
FIG. 1 FUEL CELL ASSEMBLY

An assembly drawing of the unit is given in Figure 1 and photos of same are shown in Figures 2 and 3. portion of the assembly contains six series connected cells. Both hydrogen and oxygen electrodes are platinized porous nickel discs with diameter of 6 inches and thickness of .022 inches. Twenty-five percent KOH solution is employed as the electrolyte which is impregnated in sheet asbestos. Cell separators (Figure 4) are made of nickel plated magnesium and serve a three fold purpose. First, they provide recessed areas to contain the electrodes; second, they provide gas manifolds and ports to transport the gases from the gas containers to their respective electrodes, and third, they serve to connect adjacent cells in series. The end plates of the cell stack were also made of nickel plated magnesium. Bolts are passed through each of the end plates and separators to provide a means for compressing the cell stack. Gas storage containers are made of nickel plated aluminum and form an integral part of the assembly. The gas storage volume ratio is 2/1(hydrogen and oxygen respectively). Cylinder flanges contain bolt.

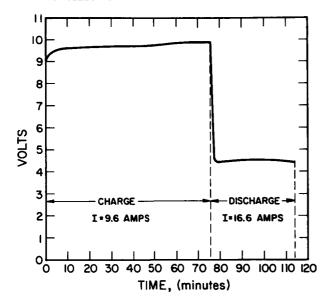
FIG. 5
ELECTRICAL PERFORMANCE
IN RUN NO. 7

Performance of the unit during the first five cycles is given in Figures 5 and 6. Electrical performance (Fig. 5 ) indicates a relatively constant charge voltage near 9.6 volts during charge at 9.6 amps and a relatively constant discharge voltage at 4.5 volts at a current of 16.6 amps. The above performance met the design goals of the contract in regard to voltage and power output. Internal temperature, (Fig. 6) (measured on the hydrogen end plate) indicated a temperature rise during discharge and a fall during charge. This result can be explained by the thermodynamics of the hydrogenoxygen reaction. During discharge, the unit generates heat from internal polarization losses as well as from the entropy change "TAS" of the reaction for the formation of water. During charge the unit generates a much smaller amount of heat from polarization losses and absorbs heat from the entropy change accompanying the decomposition of water. The "steady state" temperature range appeared to be 58°C at the end of discharge and 54°C at the end of charge.

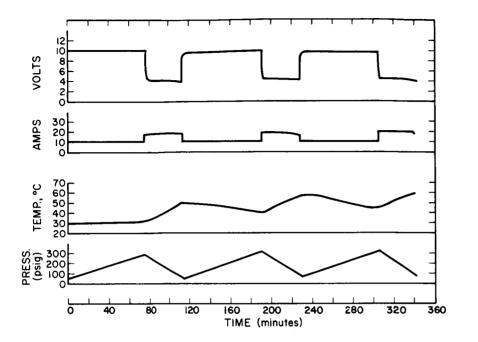
FIG. 8
PERFORMANCE OF UNIT
IN RUN NO. 10

Results of Run No. 10 (See Fig. 8) were quite encouraging in that the cell ran for about 36 hours prior to an apparent cell degradation problem. Cell performance was not, however, typical of that achieved during prior testing. Initially, this was attributed to electrode flooding caused by the higher electrolyte to asbestos ratio used. However, subsequent drying of the electrode/asbestos matrix by electrolysis did not significantly improve performance. Analysis of permeability data, plus data from the following run, indicate that the 0.020 inch type asbestos material used causes concentration polarization, due to an apparent decrease in porosity and subsequent decrease in the availability of OH ions.

Near the end of the 36 hour period, cell performance began to deteriorate rapidly on discharge. A rapid decline in cell voltage indicated that a cell reversal had occurred. Inasmuch as such a cell reversal could result in bulk gas mixing plus drying out of the asbestos of the reversed cell, it was decided to terminate this run. No apparent cause for the cell reversal was determined upon disassembly of the cell.

There are but three pertinent causes for cell reversal in the regenerative  $\rm H_2/\rm O_2$  cell. These are poor electrodes, electrolyte contamination and gas port blockage. Each of these factors was evaluated. No gas port blockage could be determined. The electrolyte was reanalyzed and found to be well within tolerance. This left electrode contamination as the most likely cause of reversal. Therefore, a new set of electrodes was prepared.

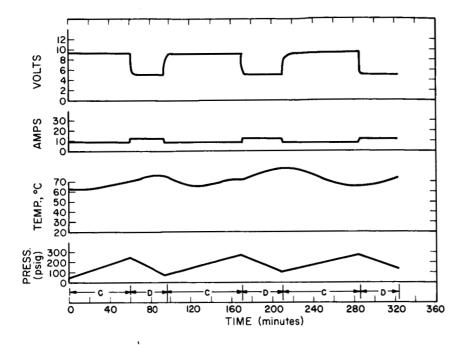
FIG. 15
PERFORMANCE OF UNIT
IN RUN NO. 13

The results of this test are given in Figure 15. Performance appeared to be satisfactory during the first few cycles, i.e., 12 amp. discharge at 5 volts. At the start of the fourth discharge period with internal pressure near 300 psig, and temperature near  $70^{\circ}$ C another ignition occurred. This ignition was much more severe than any of the others in that the gases escaped externally and the magnesium  $0_2$  end plate ignited. The door of the test chamber was also blown open during the process (See Fig. 17). The subsequent magnesium fire was extinguished with the aid of chemical fire extinguishers. Disassembly and inspection of the unit revealed severe damage to the end plates and tanks (See Figs. 18, 19, and 20).

Review of all assembly and operating records for this run as well as a thorough inspection of the unit revealed the most probable mode of failure. A short section of mylon tubing was employed on the  $\rm H_2$  leg of the differential pressure transducer instead of copper or steel due to the necessity of insulating the two cell

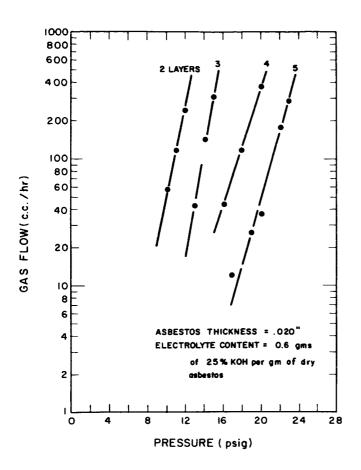
FIG. 21
PERMEABILITY OF .020"
THICK ASBESTOS

Results of the permeability studies are given in Figures 21 through 25. As would be suspected, the gas flow rate is appreciably reduced as the number of layers of asbestos is increased. For example, in Figure 21, it is noted that with the 0.020" asbestos at 10 psi, the flow rate is decreased from 52 c.c./hr. to 2 c.c./hr. (extrapolated value), as the number of layers is increased from 2 to 4 respectively. Therefore, in doubling the number of layers, one obtains a 26 fold decrease in flow rate.

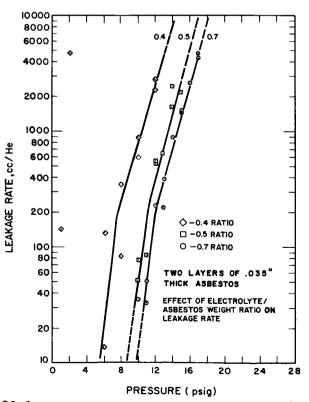
FIG. 25
EFFECT OF ELECTROLYTE CONTENT
ON PERMEABILITY OF .035" THICK
ASBESTOS

Permeability is also a strong function of electrolyte content. Inspection of Figure 25 reveals a sharp increase in gas flow as the electrolyte content is decreased from 0.5 to 0.4 gms of 25 percent KOH per gram of dry asbestos.

These results are very significant in that they place a limit on the electrochemical capacity of the fuel cell for a given grade and thickness of asbestos. This latter conclusion is based on the fact that the amp-hr. capacity is directly proportional to the water content (3 a-h/gm) which in turn is proportional to the electrolyte content.
